Monitoring of Natural Flood Management in a range of UK Catchments

Guglielmo Sonnino Sorisio¹, Daniel Jones¹, Mike Adams², Catherine
A.M.E. Wilson¹

¹ - Cardiff School of Engineering
² - Environment Agency

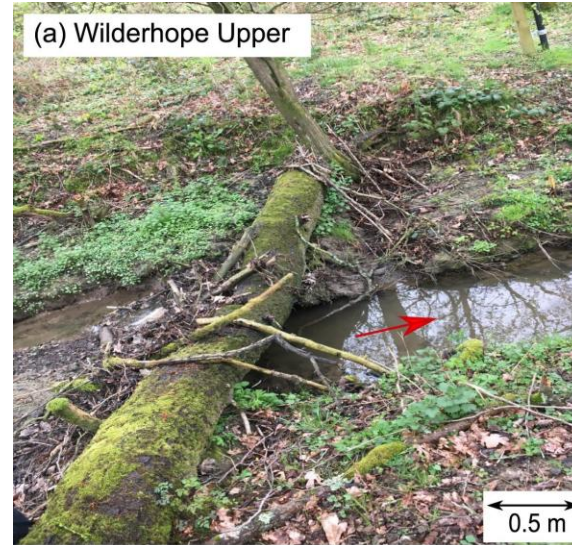
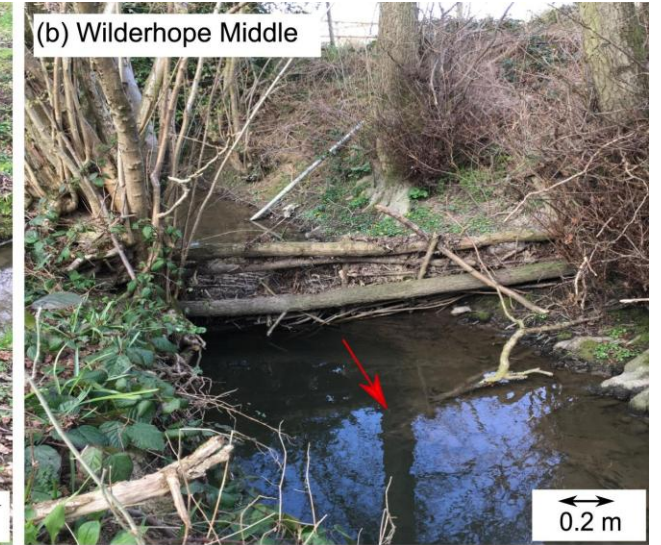
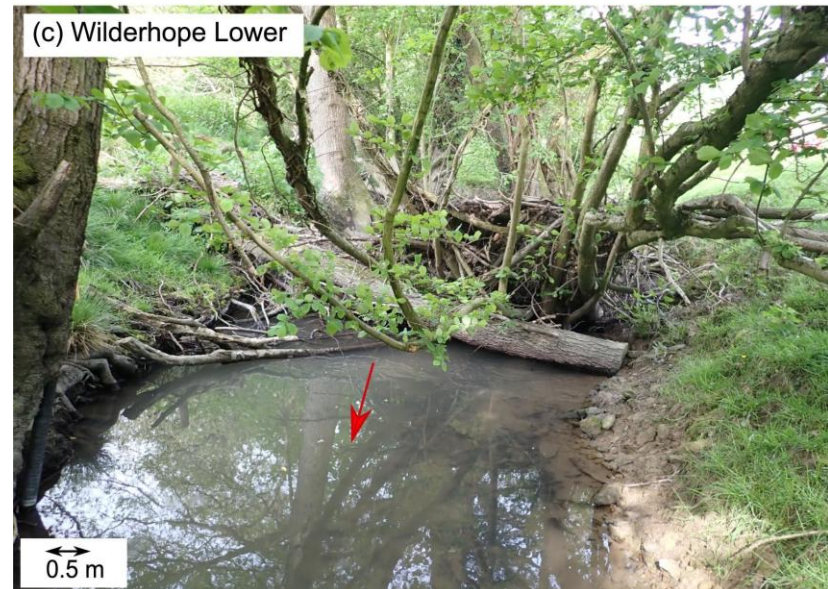
- Four leaky barriers along the reach are fully instrumented with:
- Two pressure transducers (upstream and downstream)
- Two wildlife cameras capturing the barrier from different angles and recording pictures every 15 minutes
- A rain gauge and a flow velocity sensor are also present on the reach

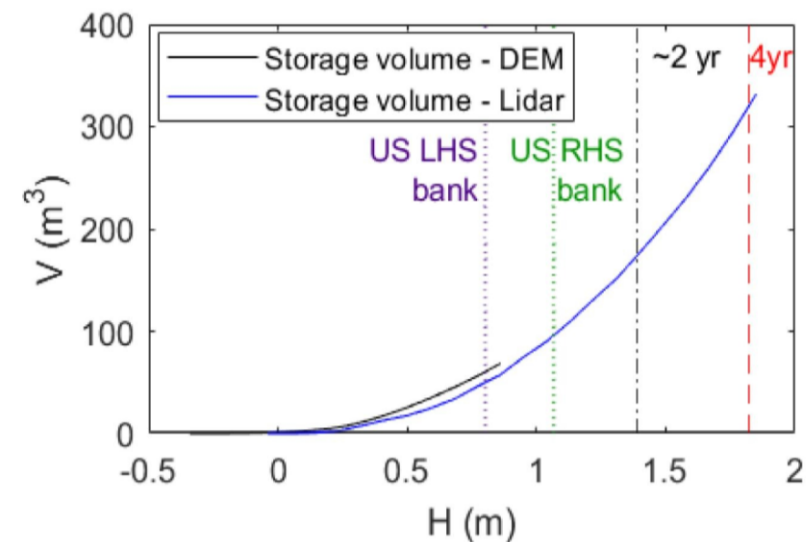
- The volume behind the Lower Barrier was evaluated through photogrammetry to estimate storage during flood events.

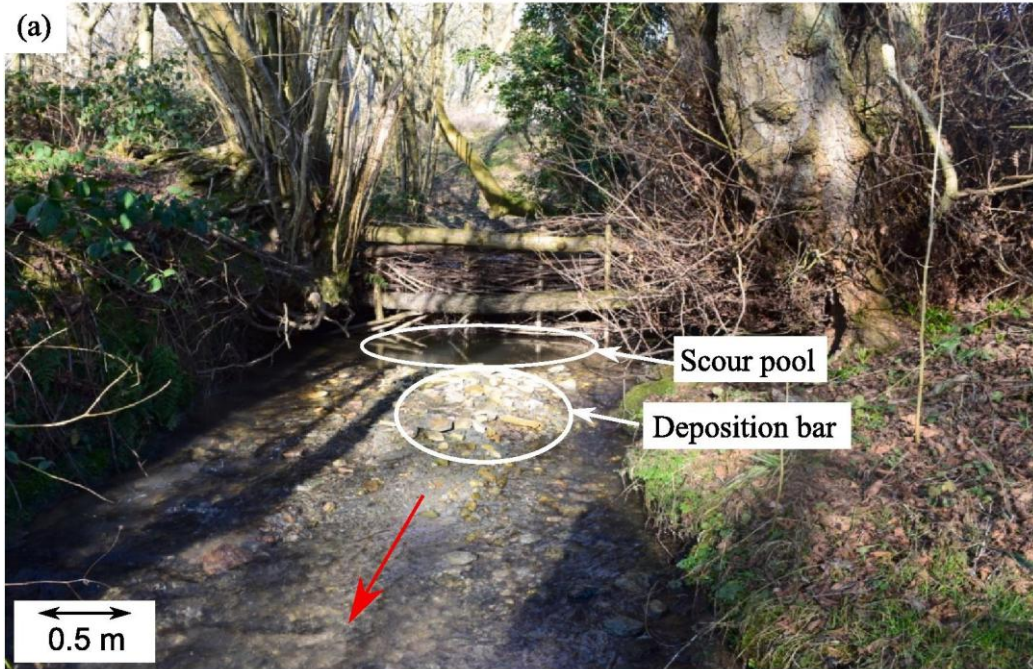
Wilderhope Middle barrier

- Local effects on sediment distribution

February 2019

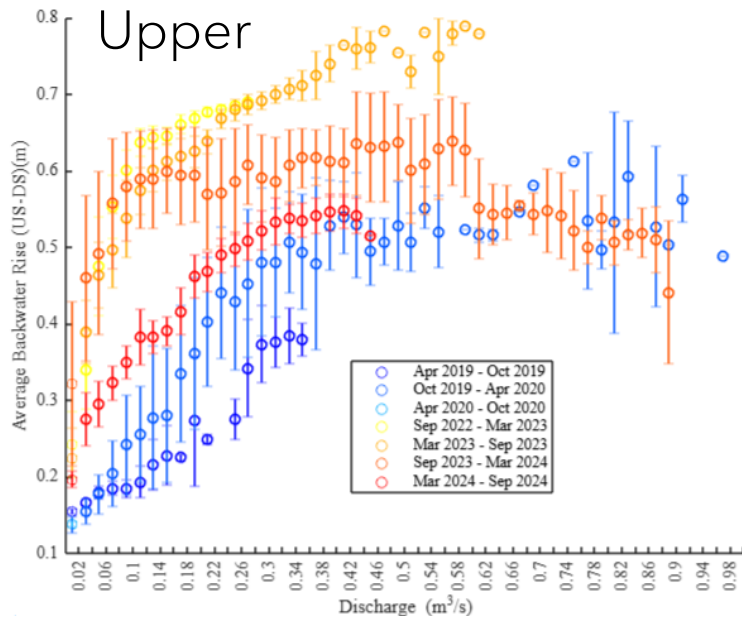
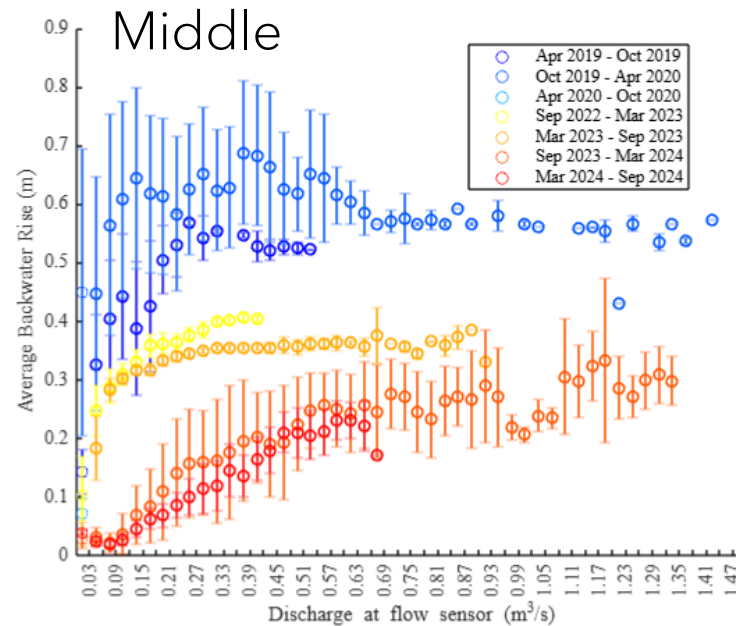
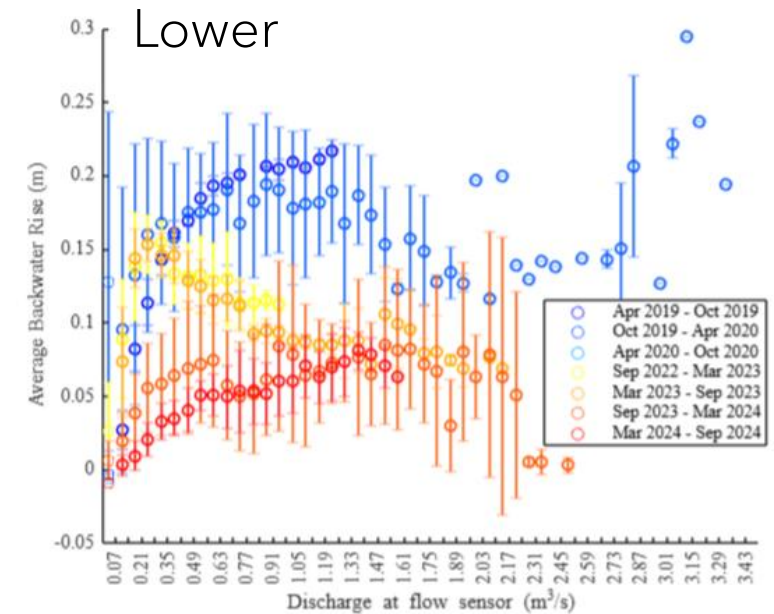
Long Term Monitoring Shows Barrier Performance Over Time

- Generally, barrier performance decreased over time, the middle barrier failed almost completely in September 2023
- The upper barrier had increased effectiveness over time, peaking in 2022

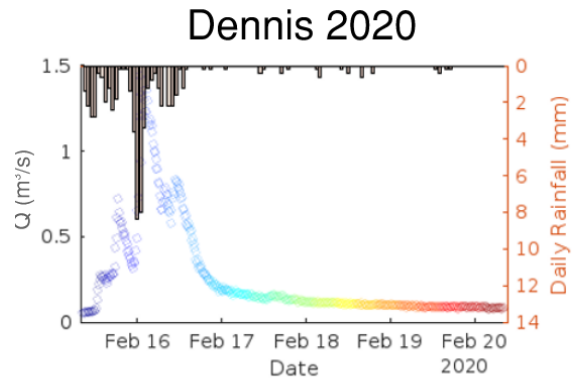
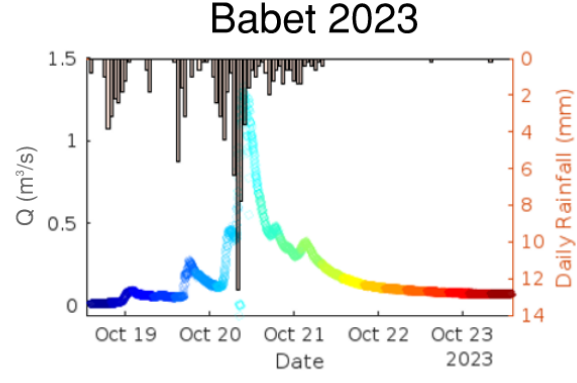
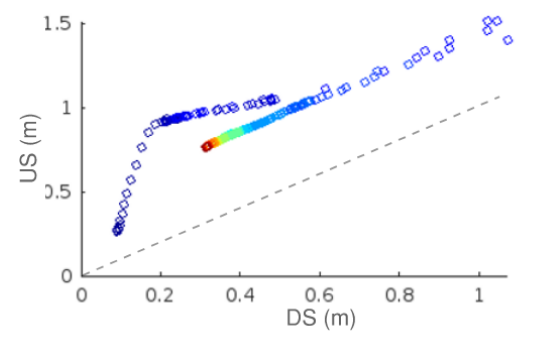
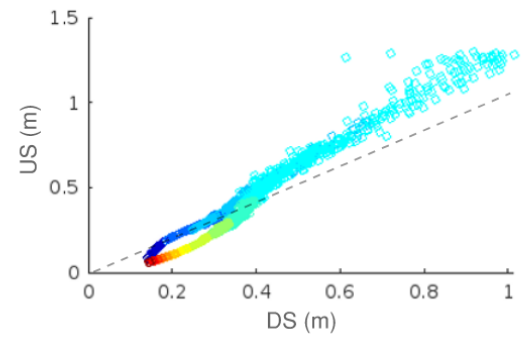
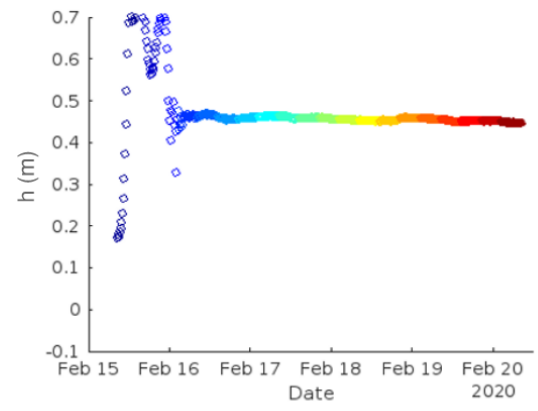
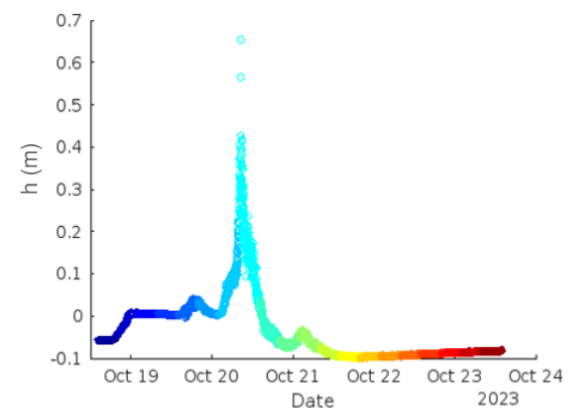
Long Term Performance and Survival Rates

- Similar storms from 2020 and 2023 shows the decreased effectiveness of the middle barrier
- Around 50% of barriers are still in place and other have been moved by flow or naturally occurred
- Conservative estimates for barrier lifespan are 5 years.

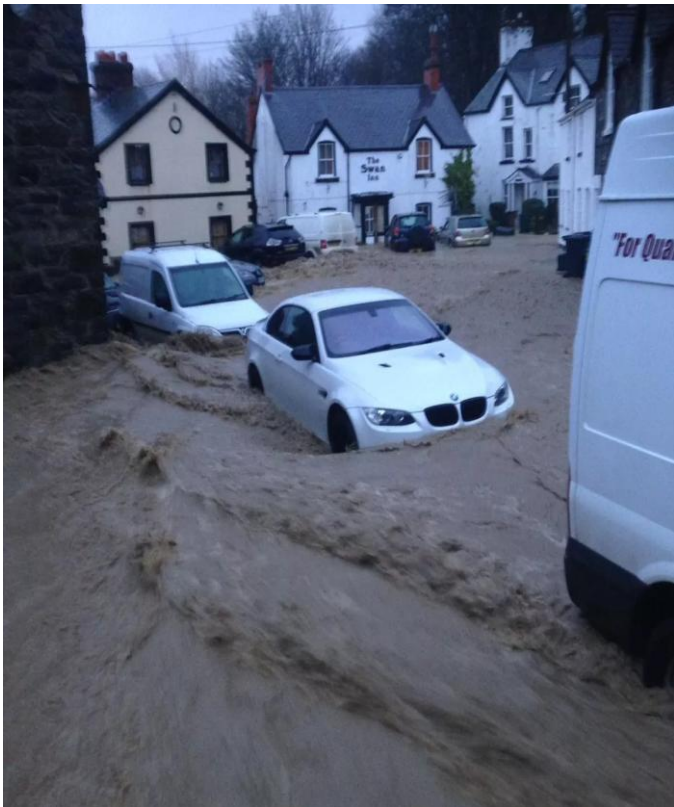
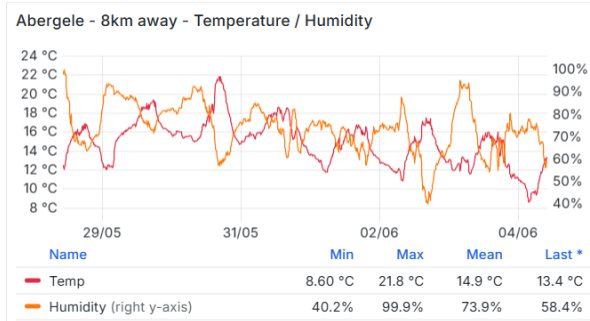
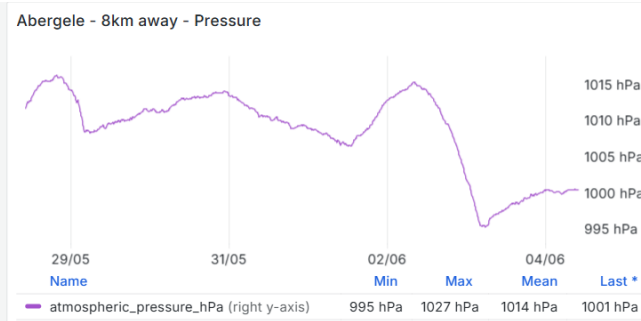
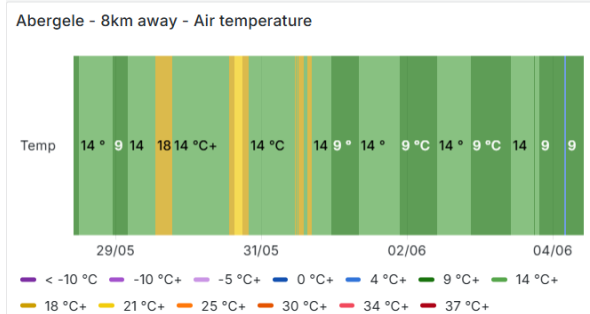
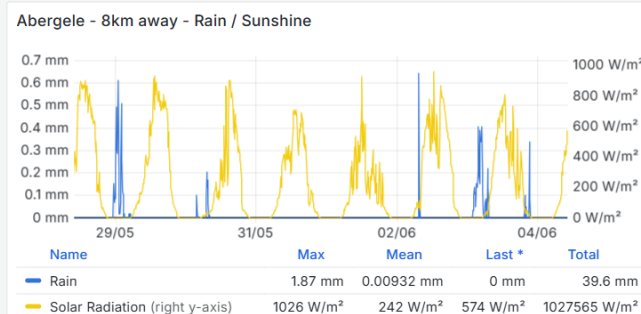
Monitoring Steep Rural Catchments

- Large scale flooding in Llanfair TH in 2020 following Storm Ciara
- The surrounding area is also susceptible to flooding
- The Nant Barrog upstream of the town features high hillslopes and bedslopes
- Local weather data and live sensor data integrated into dashboard.

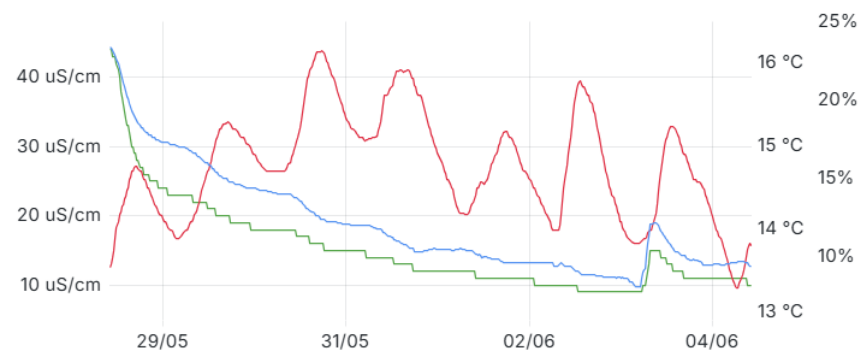
LlanfairTH, NantBarrog, Soil Moisture, Top of Field, 65421

Name	First *	Min	Mean	Max	Range
conduct_SOIL	44 uS/cm	9 uS/cm	15.2 uS/cm	44 uS/cm	35 uS/cm
temp_SOIL (right y-axis)	13.5 °C	13.3 °C	14.8 °C	16.2 °C	2.87 °C
water_SOIL (right y-axis)	23.4%	8.11%	12.1%	23.4%	15.3%

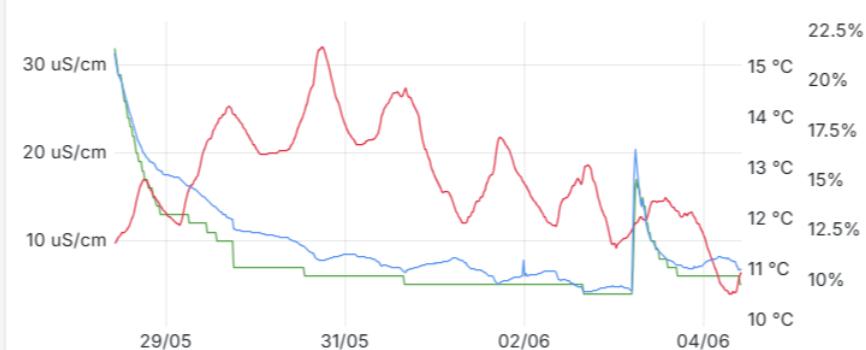
LlanfairTH, NantBarrog, Soil Moisture, Bottom of field, 65422

Name	First *	Min	Mean	Max	Range
conduct_SOIL	32 uS/cm	4 uS/cm	7.75 uS/cm	32 uS/cm	28 uS/cm
temp_SOIL (right y-axis)	11.5 °C	10.5 °C	12.8 °C	15.4 °C	4.89 °C
water_SOIL (right y-axis)	21.4%	9.41%	11.8%	21.4%	12.0%

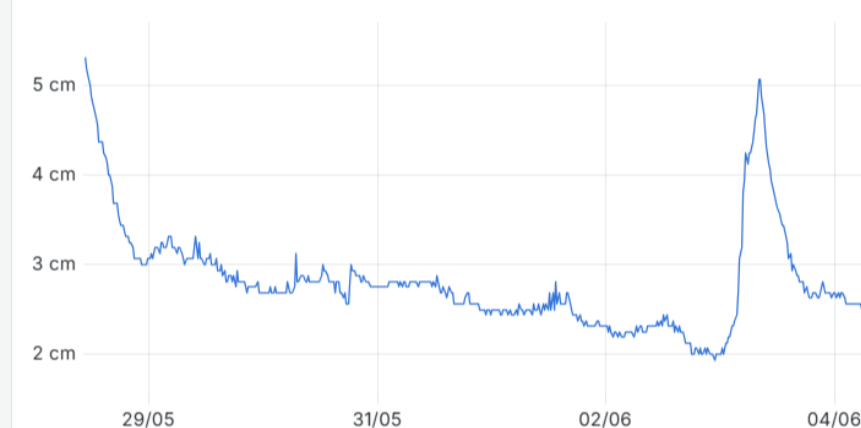
Name	First *	Last *	Min	Max	Mean	Range
Water_deep_cm	5.31 cm	2.44 cm	1.94 cm	5.31 cm	2.81 cm	3.38 cm

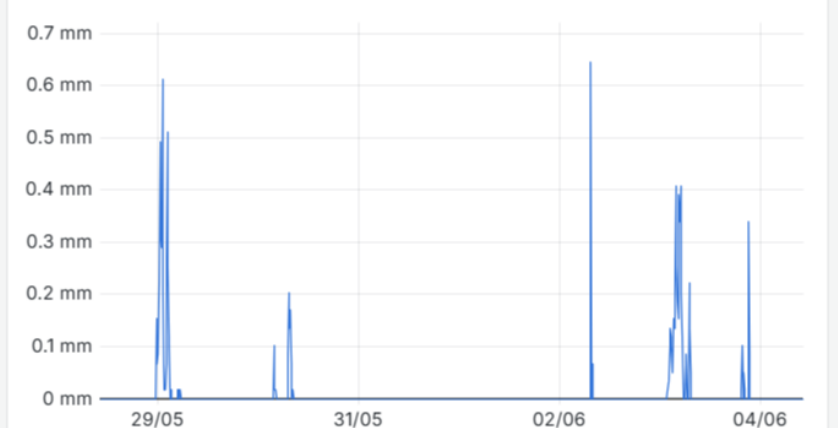
Abergele - 8km away - Rainfall

Name	Max	Mean	Last *	Total
Rain	1.87 mm	0.00932 mm	0 mm	39.6 mm

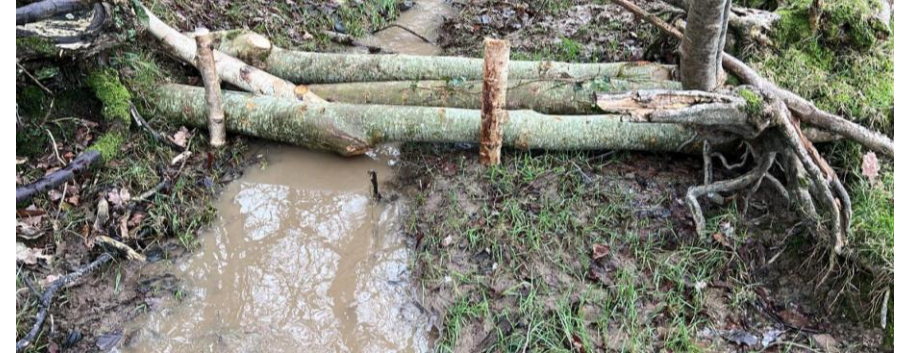
- Leaky barriers have been constructed upstream of Llansannan
- 393 barriers across multiple sites.

Site	Total number of installations
Llansannan S1	85
Llansannan S2	67
Llansannan S3	144
Dolwyddelan	93
Llansannan donor	4
Total	393

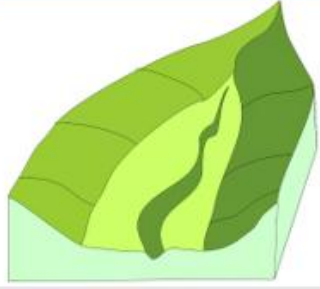
Nature Valley with minimal human interventions

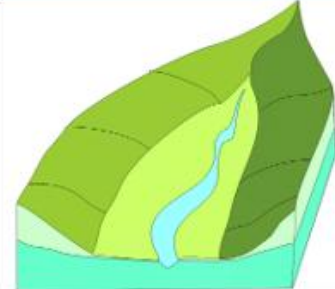
Winterbourne activities in winter	No adaption needed
Impounding Trackways

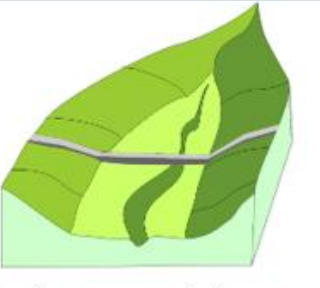
Track on causeway built across a dry valley

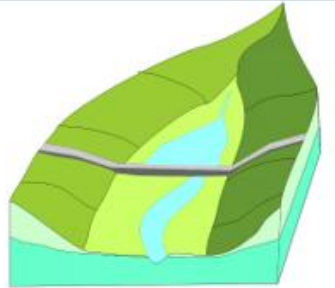
Causeway impounds water

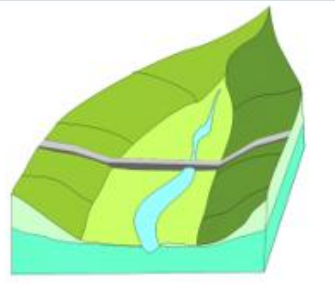
Ford or culvert installed through causeway to allow winterbourne to flow
Arable Land infill

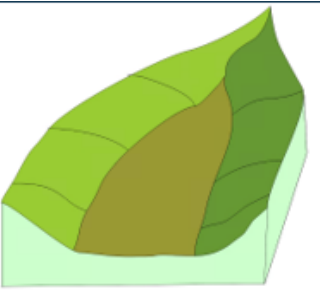
Conversion of valley floors to arable can cause winterbourne channel to be ploughed in

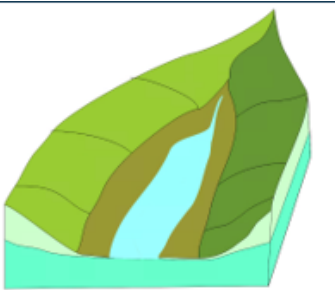
Without the winter channel water spreads over a wider area

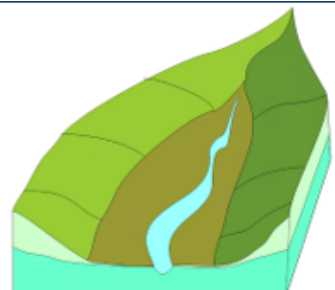
Winterbourne channels can be re-established through the creation of swales within buffer strips

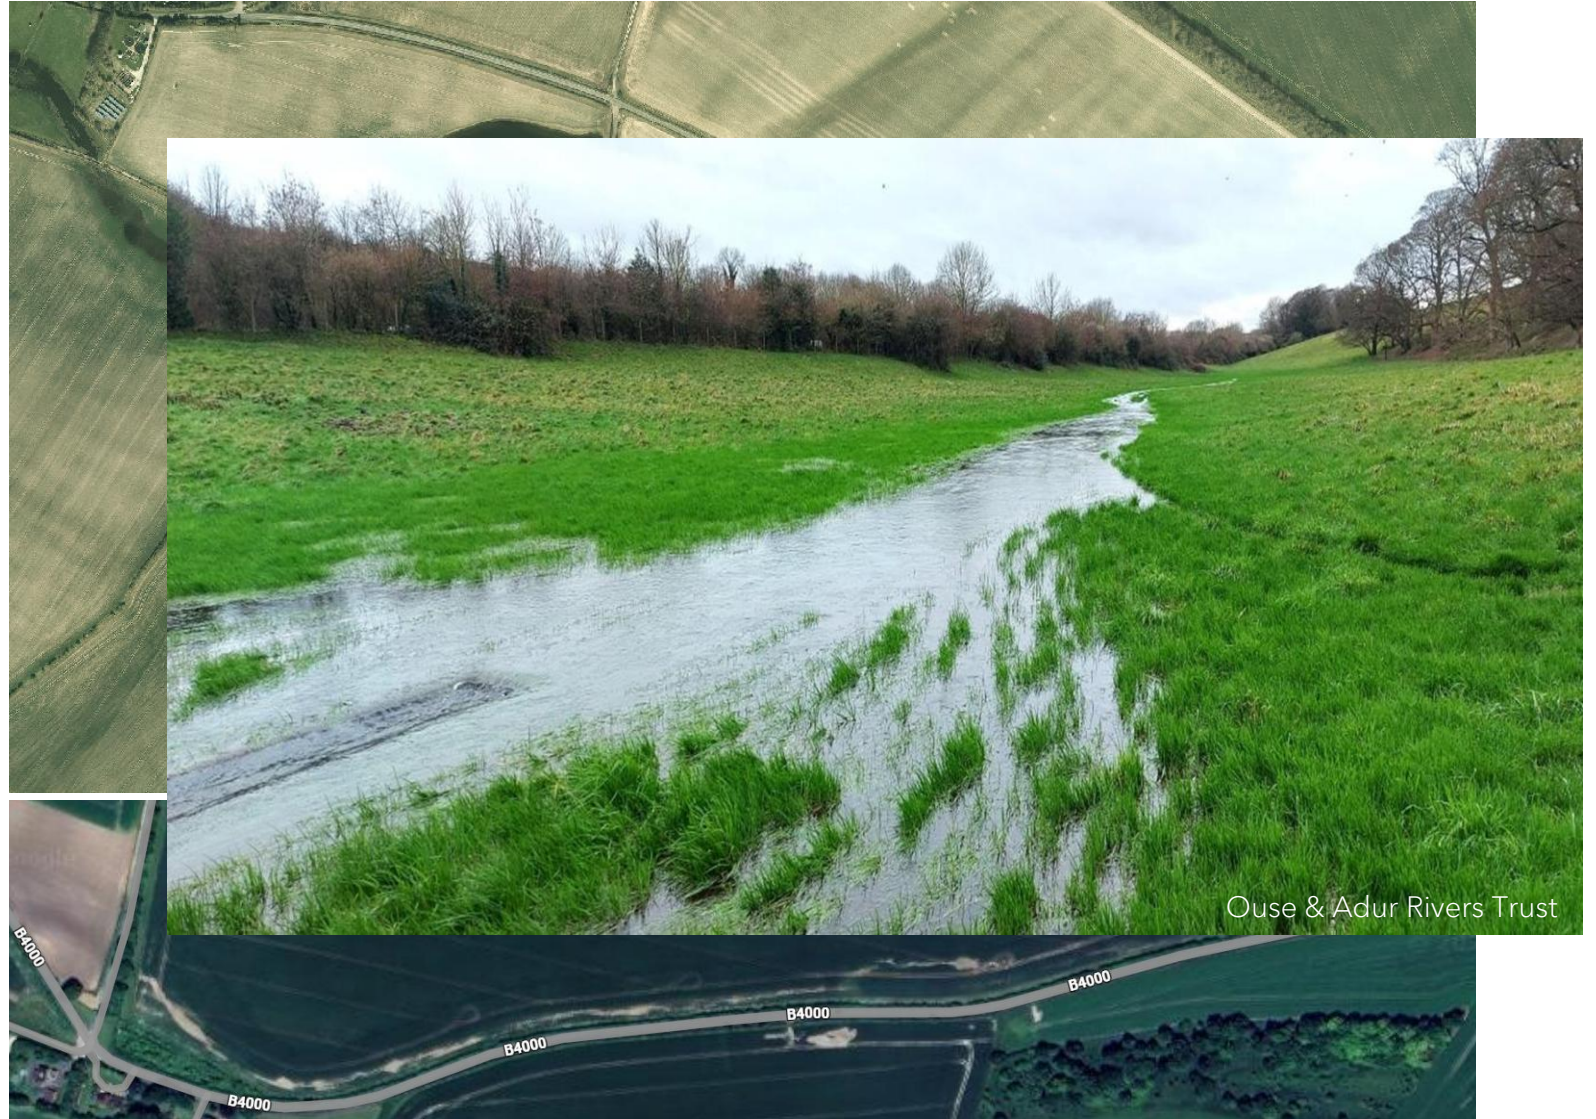
- Winterbournes are ephemeral streams that flow when groundwater levels are high
- Many of these have been destroyed and built over
- Winterbourne restoration and management could help reduce local flood risk.

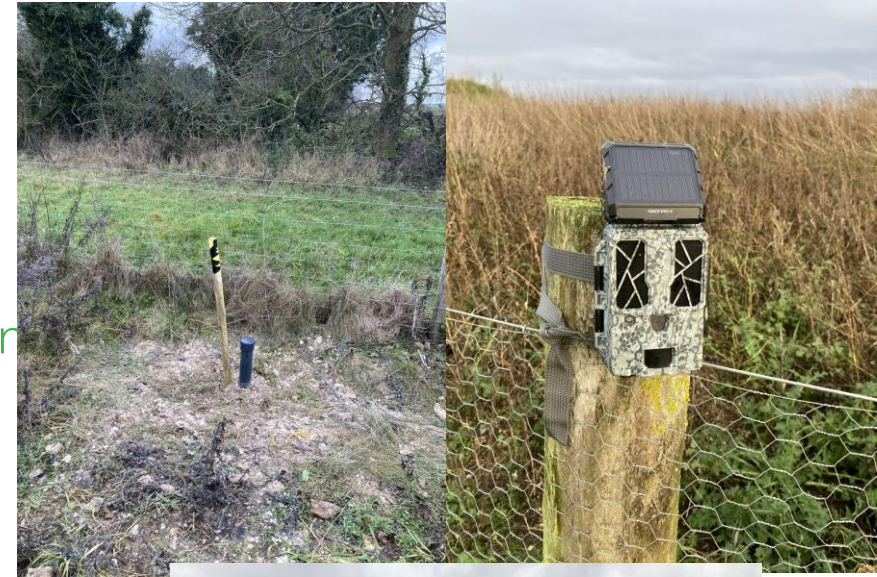
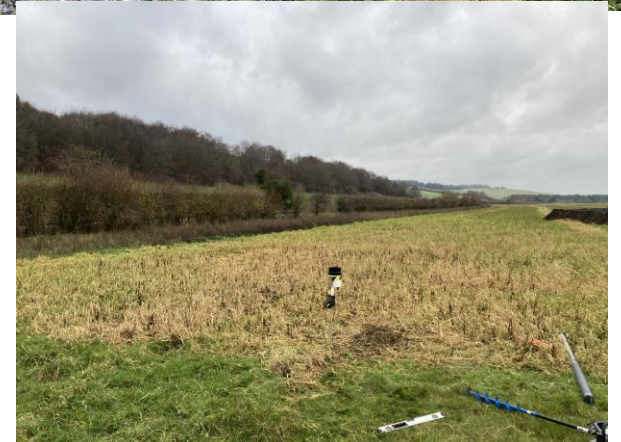
Monitoring of the winterbourne will be carried out in two phases: pre-monitoring will gather baseline data before the winterbourne is restored, post-implementation monitoring will show benefits of changes post-restoration.

- Shallow groundwater level
- Soil moisture
- Rain data
- Estimation of water storage from new features
- Wetland flow
- Surface water level
